Foreign object debris event involving Airbus A380, VH-OQI

Los Angeles International Airport, United States on 1 January 2024

Aviation Occurrence Investigation (Short)

AO-2024-006

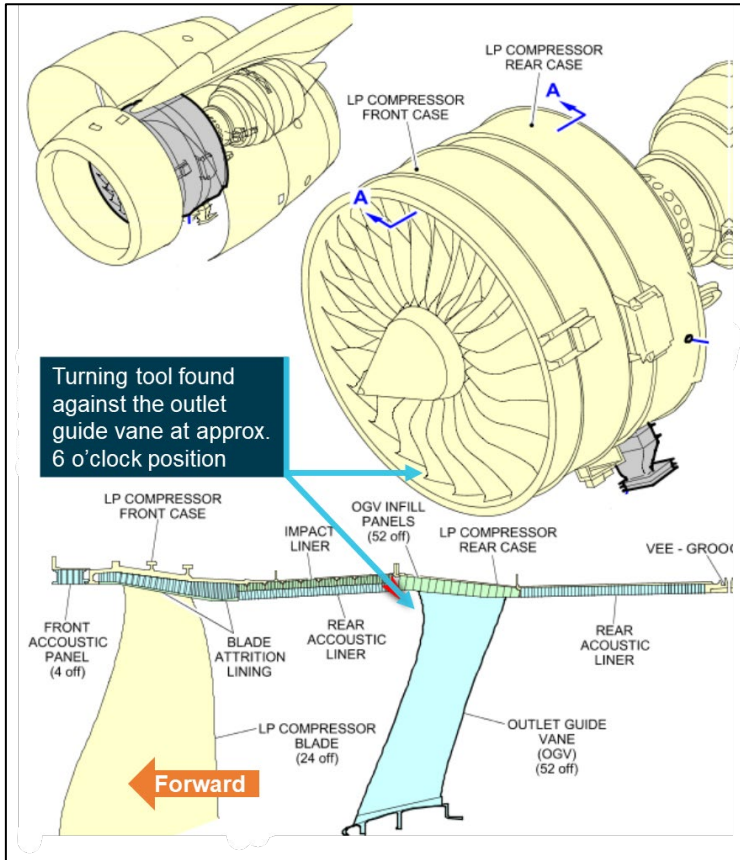
Figure 2: Schematic of the Rolls Royce Trent 972-84 engine identifying the location of the turning tool
